NISTIR 88-4008

Corrosion of Metallic Fasteners in Low-Sloped Roofs: A Review of Available Information and Identification of Research Needs

*U.S. DEPARTMENT OF COMMERCE
National Institute of Standards and Technology
(Formerly National Bureau of Standards)
National Engineering Laboratory
Center for Building Technology
Gaithersburg, MD 20899

February 1989

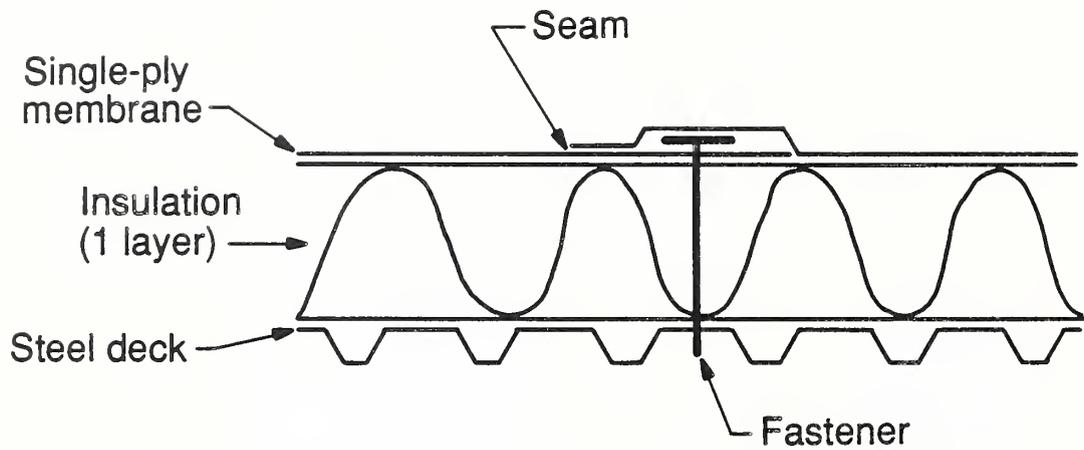
B) Fastening Membrane and Insulation

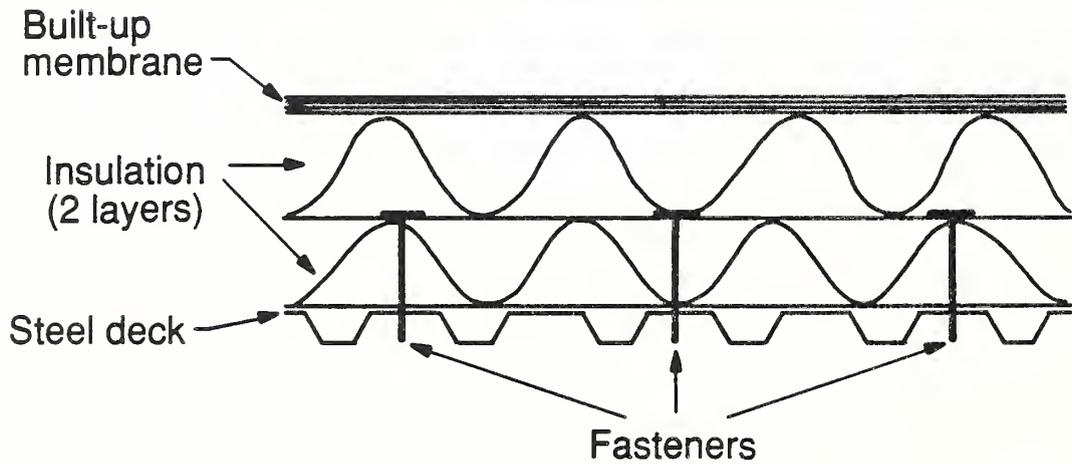
A) Fastening First Layer of Insulation

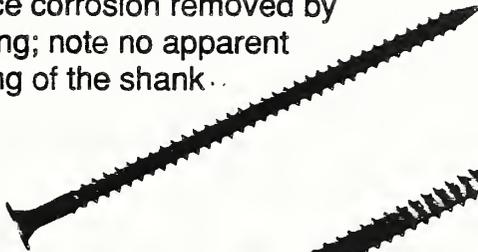
Surface corrosion removed by cleaning; note no apparent thinning of the shank.

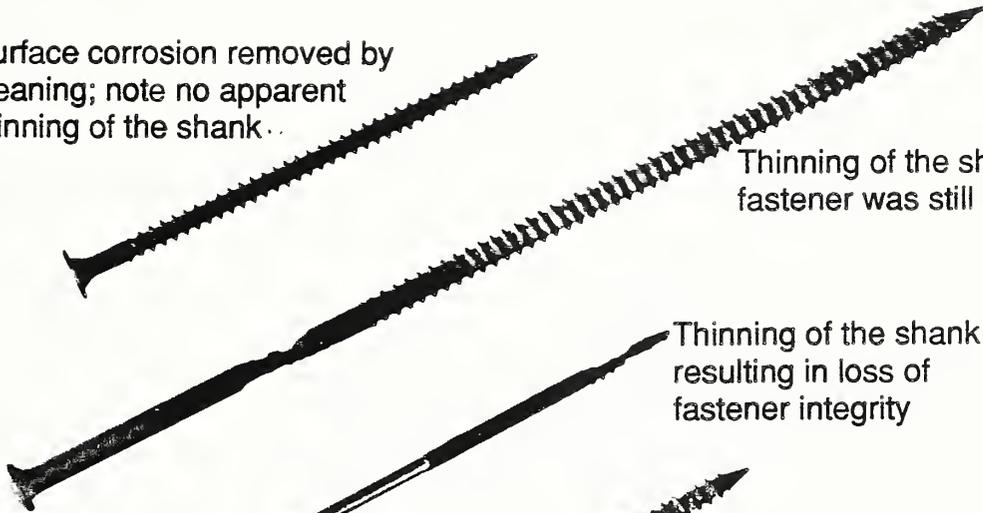
Thinning of the shank; fastener was still intact

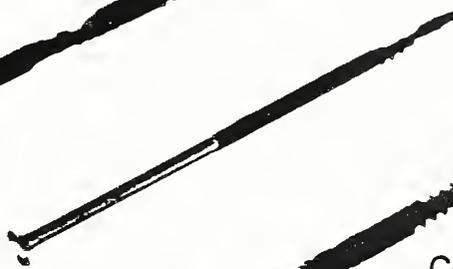
Thinning of the shank resulting in loss of fastener integrity

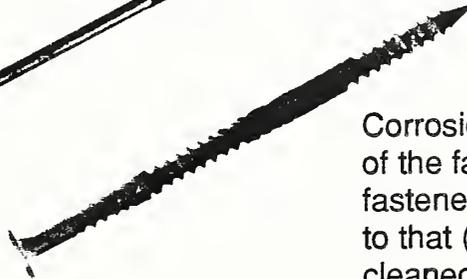
Figure 3. Fasteners That Experienced Corrosion In Service

Corrosion on the surface of the fastener; this fastener appeared similar to that (above) which was cleaned

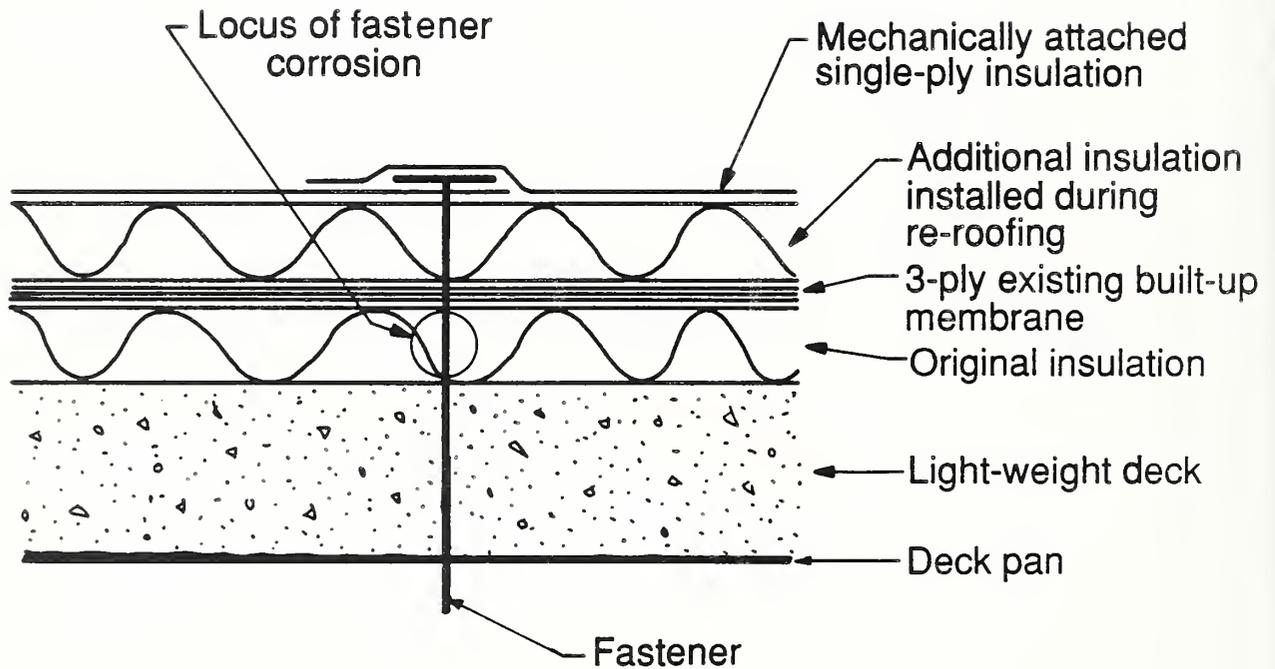
Figure 4. Cross-Section of a Mechanically-Attached Single-Ply Membrane System Installed Over An Existing Built-Up Membrane System (not to Scale). The Fastener Experienced Marked Thinning of the Shank in the Area Within the Insulation
